Evaluation of a Containment Barrier for Hazardous Material Spills in Watercourses

Samson Ocean Systems, Inc., Boston, MA

EPA-600/2-83-112
November 1983

Thomas N. Blockwick
Samson Ocean Systems, Inc.
Boston, Massachusetts 02110

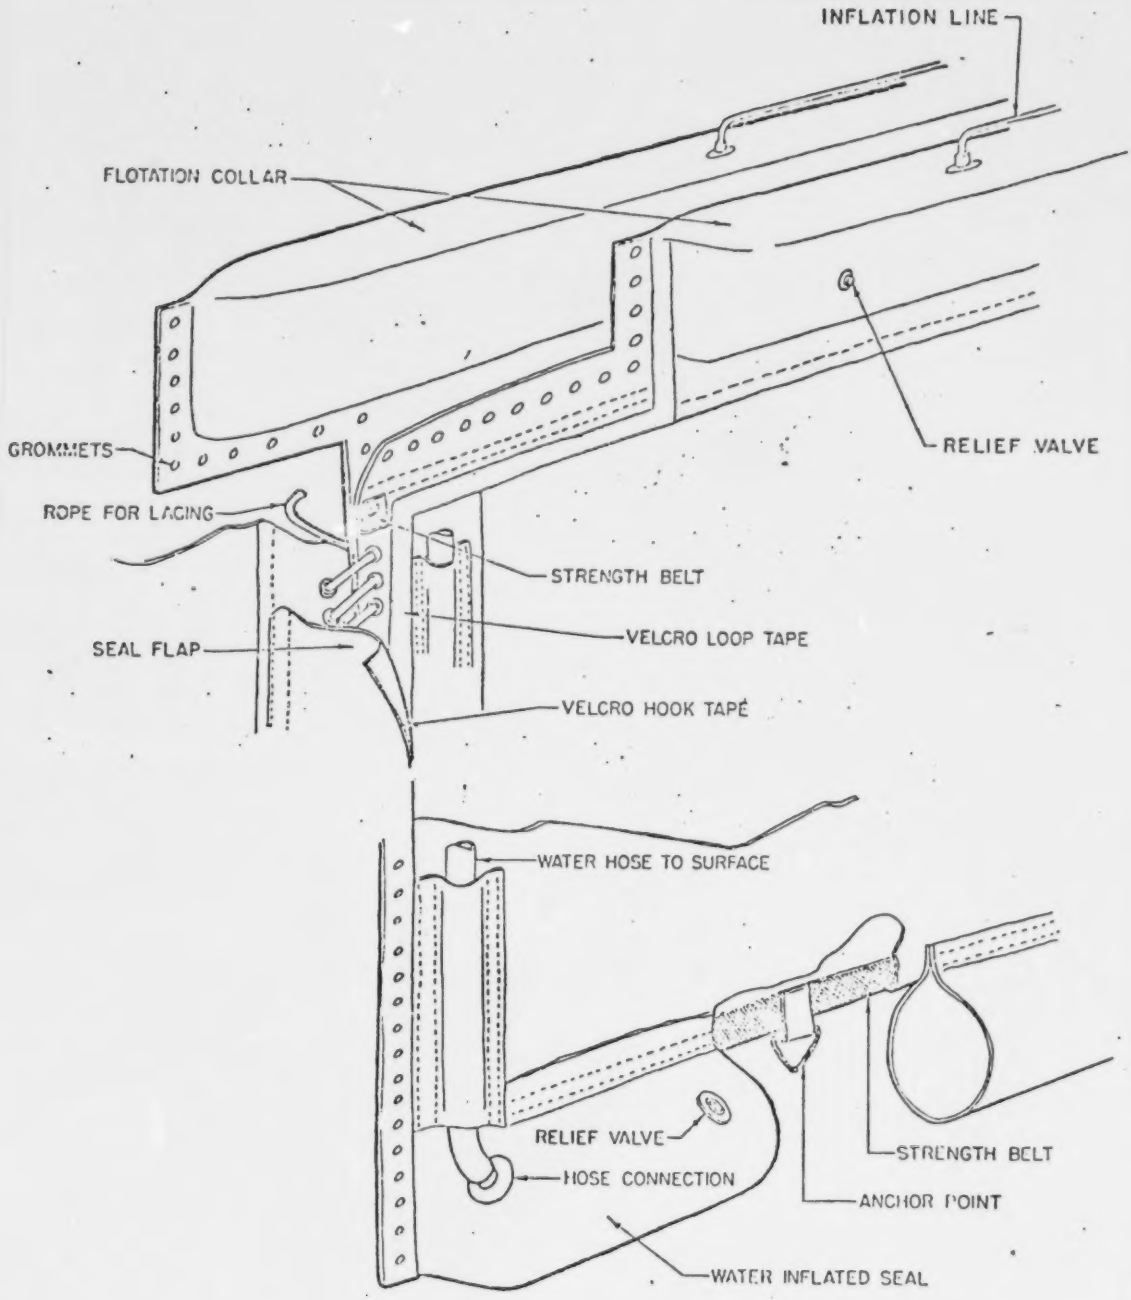
Figure 3. Details of barrier construction.

Visual observation of the barrier at the time of failure in the 1972 Palm Beach test indicated that the barrier wall tore initially in the vicinity of anchor No. 1. The barrier wall continued to tear away from the strength belt for almost the full circumference of the barrier until the barrier was "feathered" in the current and the dynamic load was released.

It is believed that dynamic pressure on the barrier wall caused the fabric to pull very hard at the sewn seam. The pressure of the stitches on the fabric caused the fabric to begin to fail in a tensile mode. As soon as a short length of the wall had failed in this mode, the fabric began to fail in a tear mode. The fabric will, of course, fail much easier in the tear mode since all of the load is put on the few fibers at the tear point. After tearing for a few yards through the double layer of material at the sewn seam, the tear jumped up the barrier wall just above the welded joint where it continued for the circumference of the barrier.

In the direction of the No. 5 anchor, the tear spread for almost the full length of the barrier, while in the direction of the No. 2 anchor it went only approximately 20 ft until it was checked by the 2-in. webbing in the vertical joint. Here it continued upward along the webbing until it reached a point just under the flotation collar. That the tear was checked by the 2-in. webbing and then ran up alongside the webbing, suggests that had vertical belts been included in the barrier, they would not have prevented failure.

Another area of the barrier design where failure occurred is that of the seams in the bladders. The barrier, as presently designed and constructed, uses a simple type of seam for the bladders. Although this seam has an adequate vertical strength, and material tests during the construction of the barrier indicated adequate strength of the joint, the electronic weld did fail by peeling and the row of stitching down the middle of the electronic weld prevented the bladder from bursting. The flotation collar was pneumatically tested after construction by pumping it up with the air compressor until the relief valves vented. All of the valves operated properly, which indicates that failure of the seam was not caused by overpressurization. Instead, it is believed that the electronic weld "peeled" in a long-term creep mode when the bladders were pressurized during the first field test.

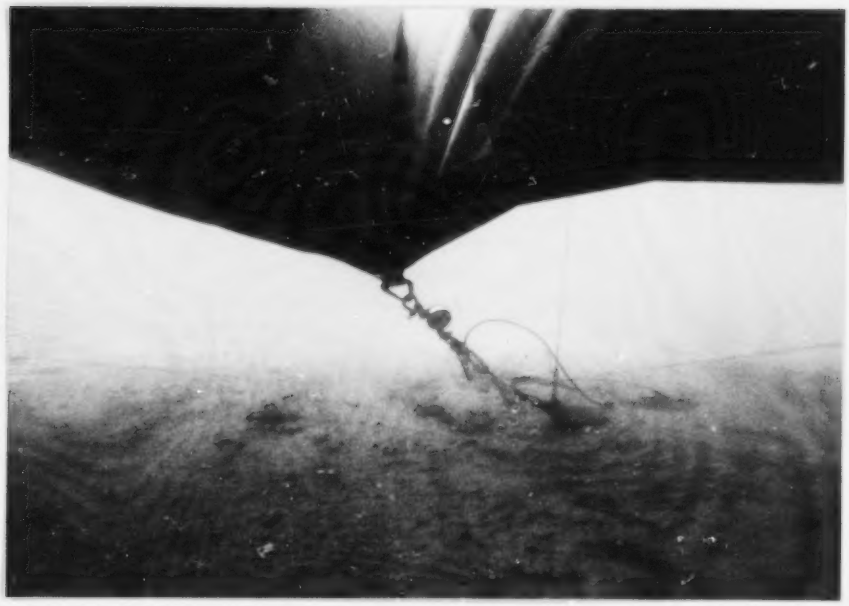
Figure 15. Fully inflated bottom seal rising above lake floor.

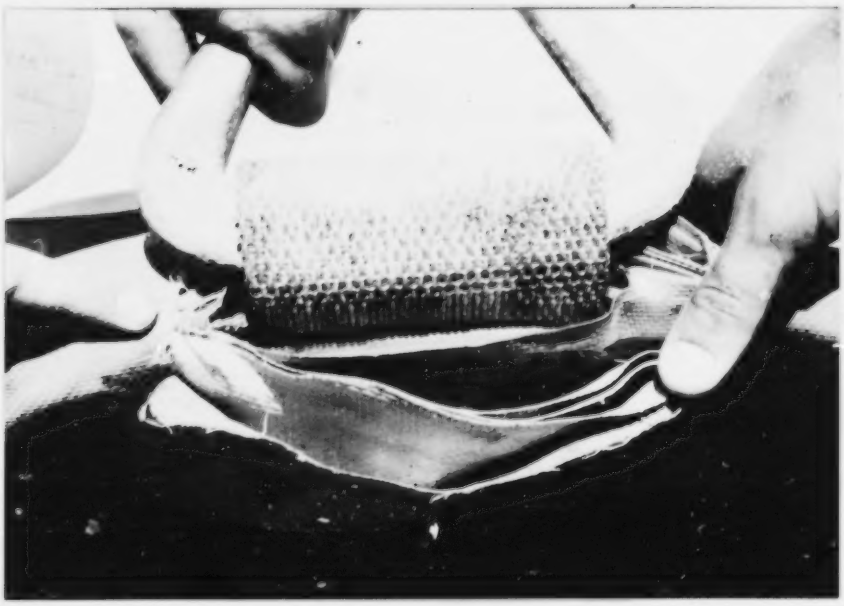
Figure 17. Tears around "D" ring.

Inspection later revealed some structural damage, peeling welds, and several holes to the air and bottom seal bladders and the curtain wall, in addition to the intentional slashes. The barrier was folded and stored on a pallet pending further action.
